NAVORD REPORT

4422

EVALUATION OF COATING TREATMENTS FOR MAGNESIUM ALLOY TUBING

26 October 1956

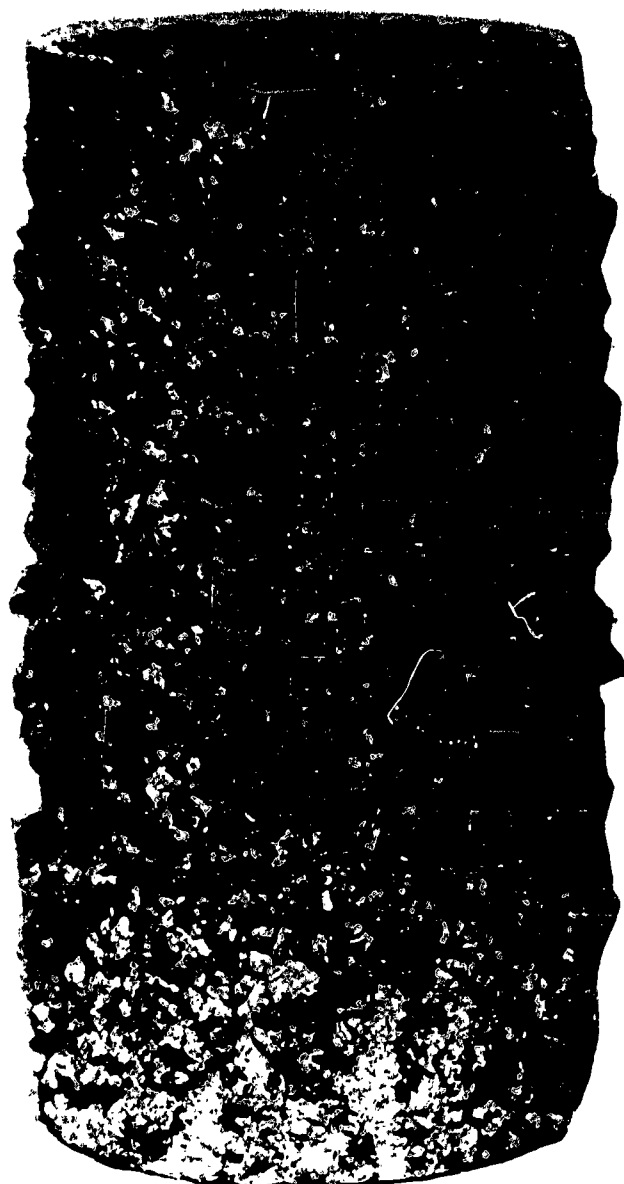
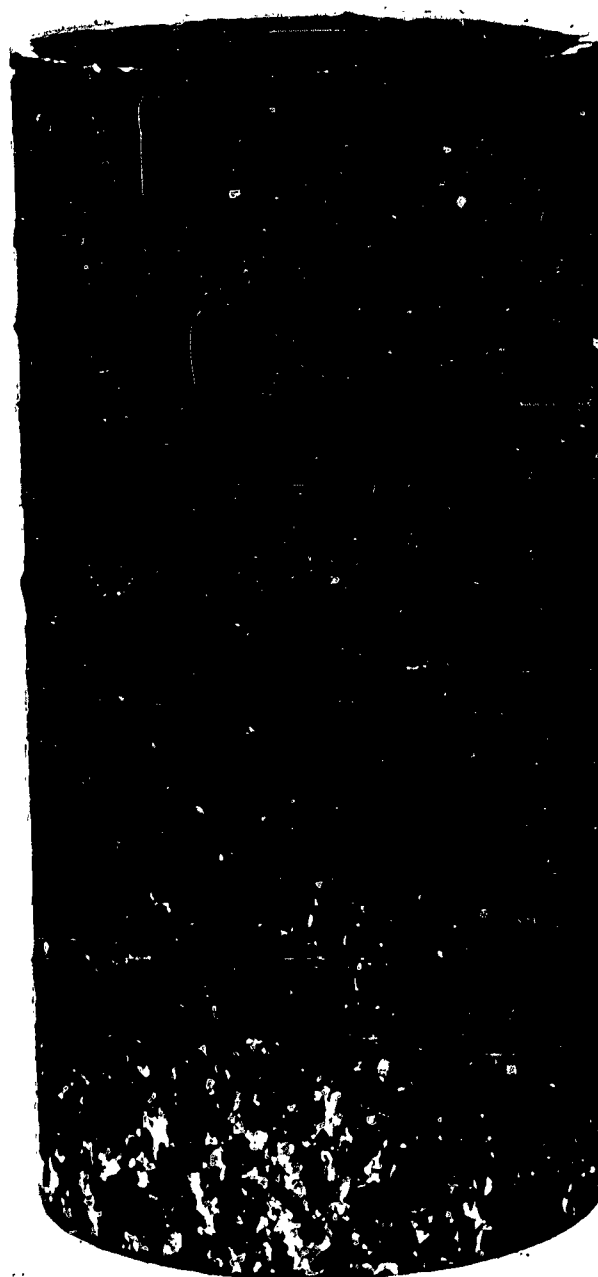
8. Tube No. 15 had a high voltage H.A.E. coating, .0002 inch thick, and had been aged. This system showed the greatest coating penetration by salt spray (fog) testing. Heavy lengthwise markings were noted within 23 hours of salt fog exposure. Figure 1 shows the condition of the tube when removed from the test after 96 hours of exposure. After photographing the unwashed tube, warm water and a soft brush were used to remove the magnesium hydroxide and salt prior to

rephotographing. The washed tube indicates the large amount of surface pitting. Two coats of zinc chromate primer in addition to the above H.A.E. aged coating (tube No. 16) provided protection for less than 48 hours. Figure 3 indicates the extent of coating penetration on tube No. 16 by 192 hours of exposure.

15
UNWASHED

15
WASHED

FIG. 1 SALT SPRAY (FOG) TEST - 96 HOURS
H.A.E. COATING ON MAGNESIUM TUBE (SEE TABLE I)

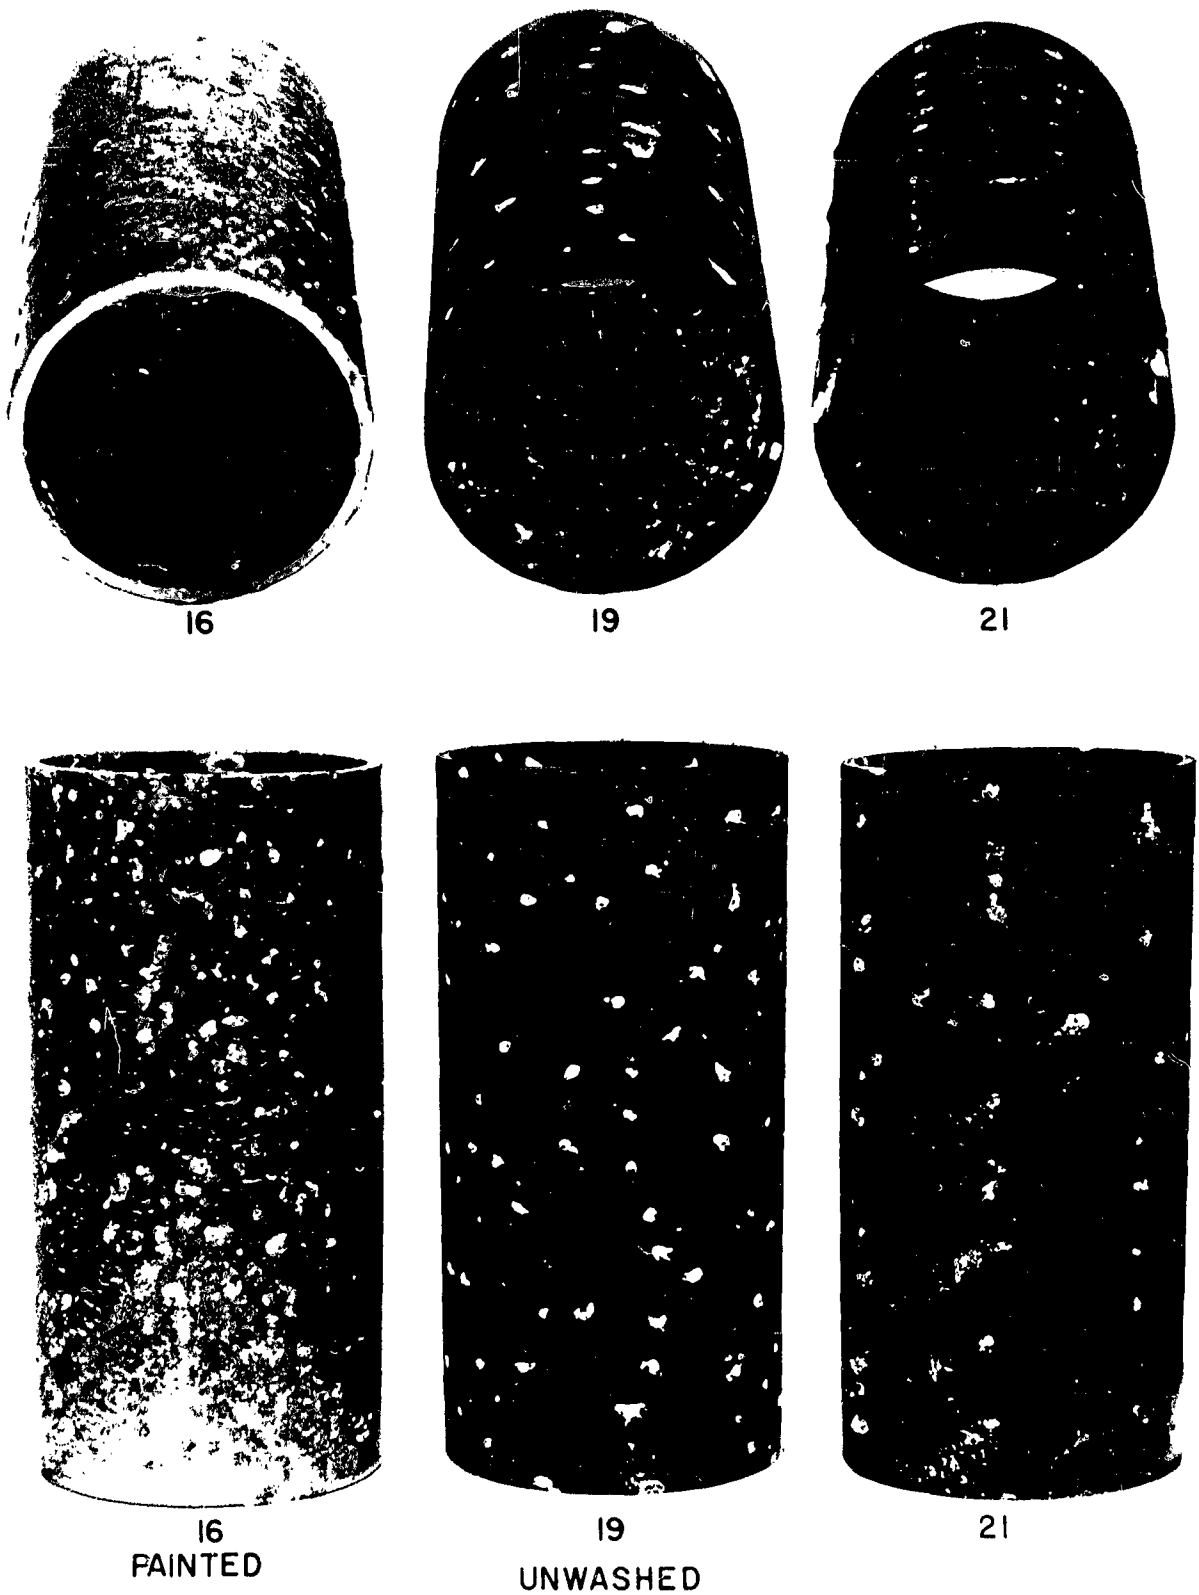
12. High voltage H.A.E. coating, .002 inch thick, and aged provided the greatest protection of the H.A.E. coatings which were tested. Tube No. 21 showed slight breakdown after 192 hours of exposure (Figure 3). When two coats of zinc chromate primer were applied on tube No. 22, very slight breakdown was noted on the inside of the tube and none on the outside (Figure 4).

FIG. 3 SALT SPRAY (FOG) TEST - 192 HOURS
VARIOUS H.A.E. COATINGS ON MAGNESIUM TUBES (SEE TABLE I)

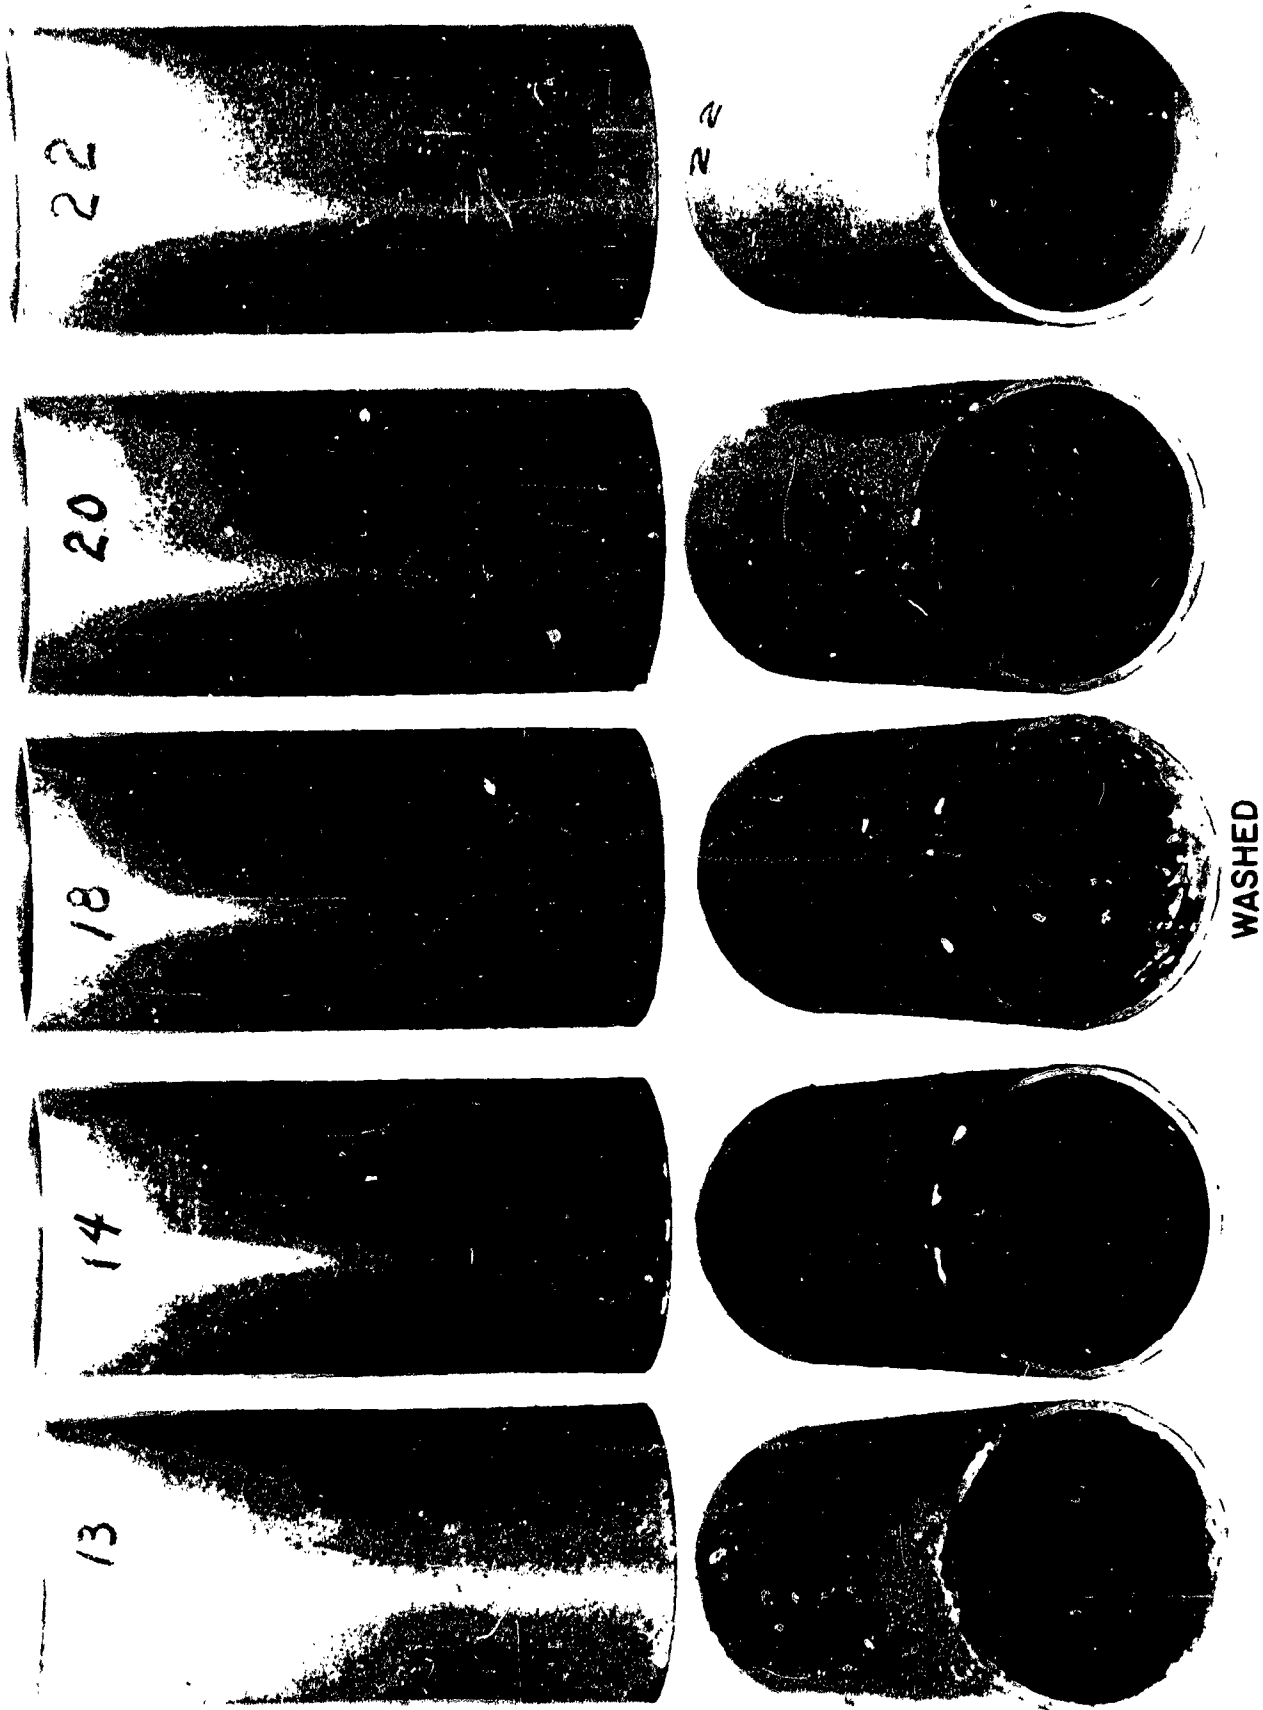
11. When high voltage H.A.E. coatings were applied .0015 inch thick and aged on tubes No. 19 and 20, an increase in protection was noted over the thinner applications. Some slight breakdown was noted on No. 19 after 48 hours. After removal at 192 hours of exposure, examination indicated greater breakdown on the inside of the tube than on the outside (Figure 3). Tube No. 20, which had been given two coats of zinc chromate primer, also showed greater breakdown on the inside of the tube. Figure 4 indicates very little breakdown on the outside other than that noted on the lower edge of the tube.

FIG. 4 SALT SPRAY (FOG) TEST - 240 HOURS
PAINTED VARIOUS H.A.E. COATINGS ON MAGNESIUM TUBES (SEE TABLE I)

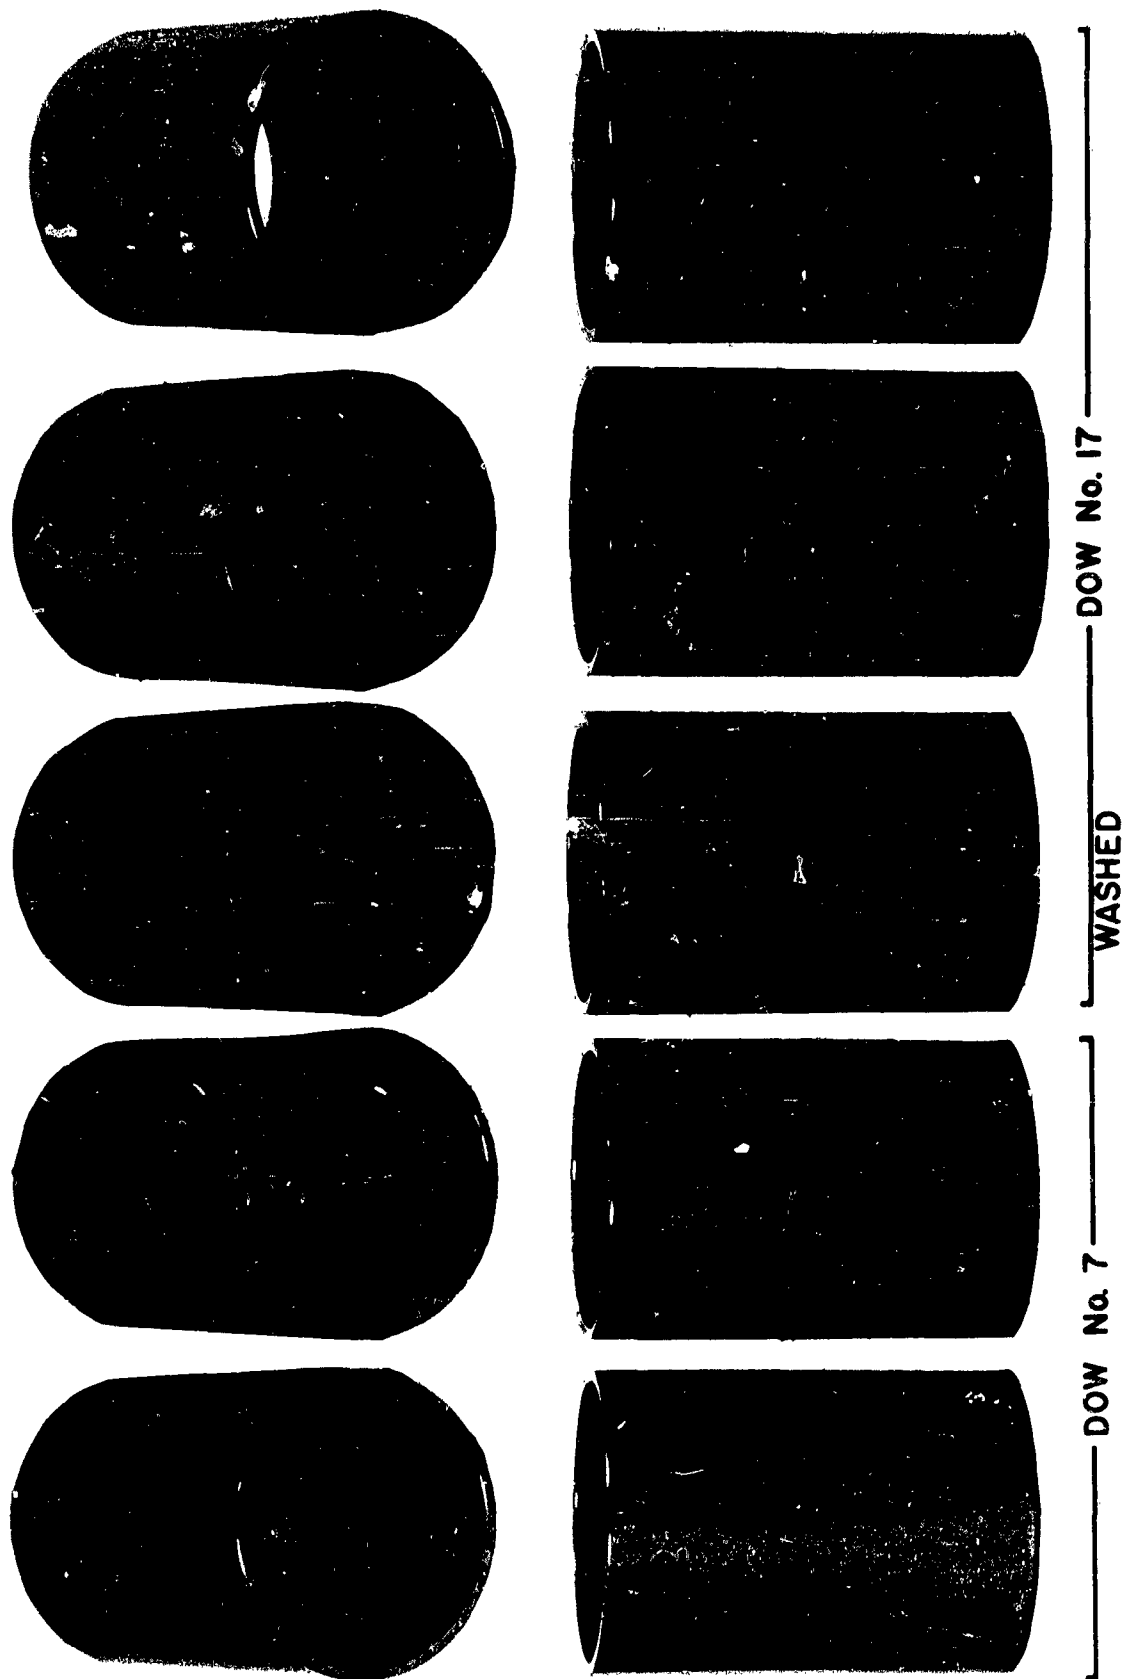
14. Coating systems which included Dow No. 7 and Dow No. 17 were tested for 240 hours. As indicated by Figure 6, no breakdown was noted on Dow No. 7 tubes. (Tube No. 6 shows an uneven painted surface at the clamp mark obtained during processing.) Most of the breakdown and blisters noted on Dow No. 17 tubes may be attributed to inadequate paint coating at clamp marks obtained during processing. In addition, some breakdown was noted on the edges of tube No. 10.

FIG. 6 SALT SPRAY (FOG) TEST-240 HOURS
PAINTED DOW COATINGS ON MAGNESIUM TUBES (SEE TABLE I)

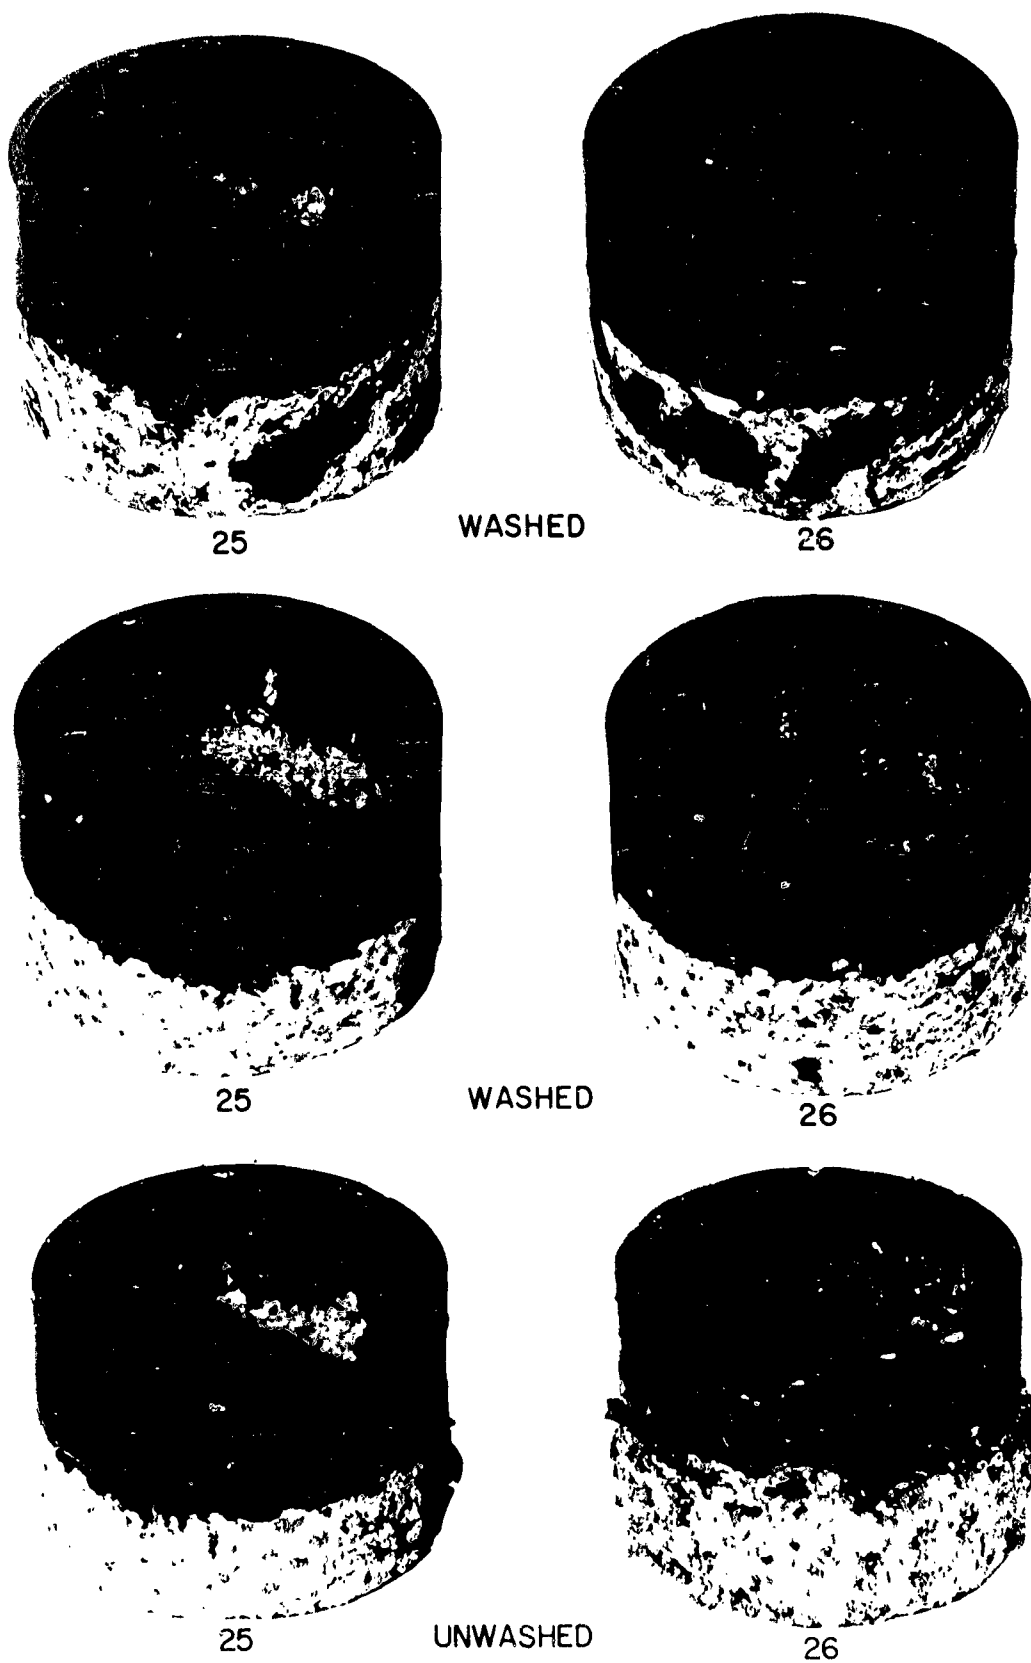
15. Duplicate samples were available of those systems which included Iridite 15. Two tubes, No. 25 and 26, were painted over the Iridite coating only on the upper half of the tube. The unpainted Iridite 15 coating was heavily marked within 24 hours of exposure, but breakdown was not noted on the painted half of the tubes until 165 hours. The large amount of blistering and chipping of the painted surface by 240 hours (as noted in Figure 7) may be the effect of lifting of the paint film from the underside, or by the corroding magnesium on the unpainted half of the tubes. For this reason, additional Iridite 15 tubes were tested either completely painted or unpainted.

FIG. 7 SALT SPRAY (FOG) TEST- 240 HOURS
IRIDITE 15 COATING (PARTLY PAINTED) ON MAGNESIUM TUBES
(SEE TABLE I)

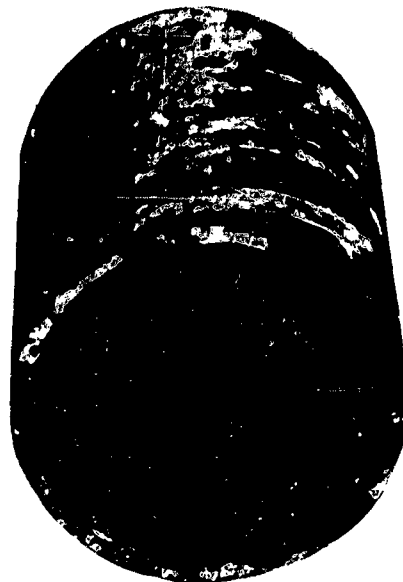
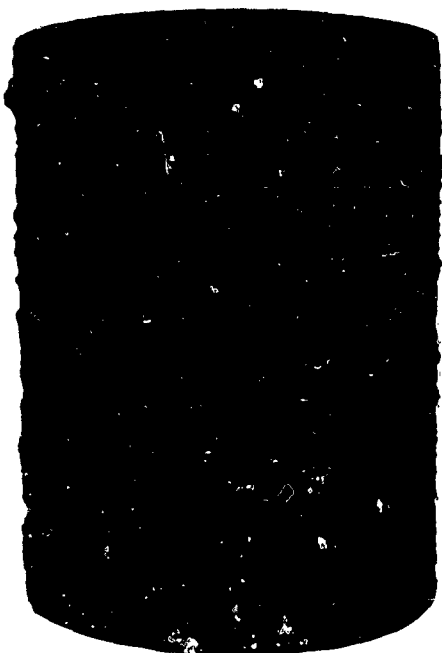
16. Three unpainted tubes with Iridite 15 were heavily marked within 24 hours of exposure. Tubes No. 23 and 24 were removed from testing after 96 hours. Tube No. 27 was photographed after 96 hours and returned to the salt spray test for additional exposure. The additional breakdown noted on tube No. 27 by 240 hours may be compared with 96 hours exposure on tubes No. 23 and 27 in Figure 8.

FIG. 8 SALT SPRAY (FOG) TEST
IRIDITE 15 COATING ON MAGNESIUM TUBES

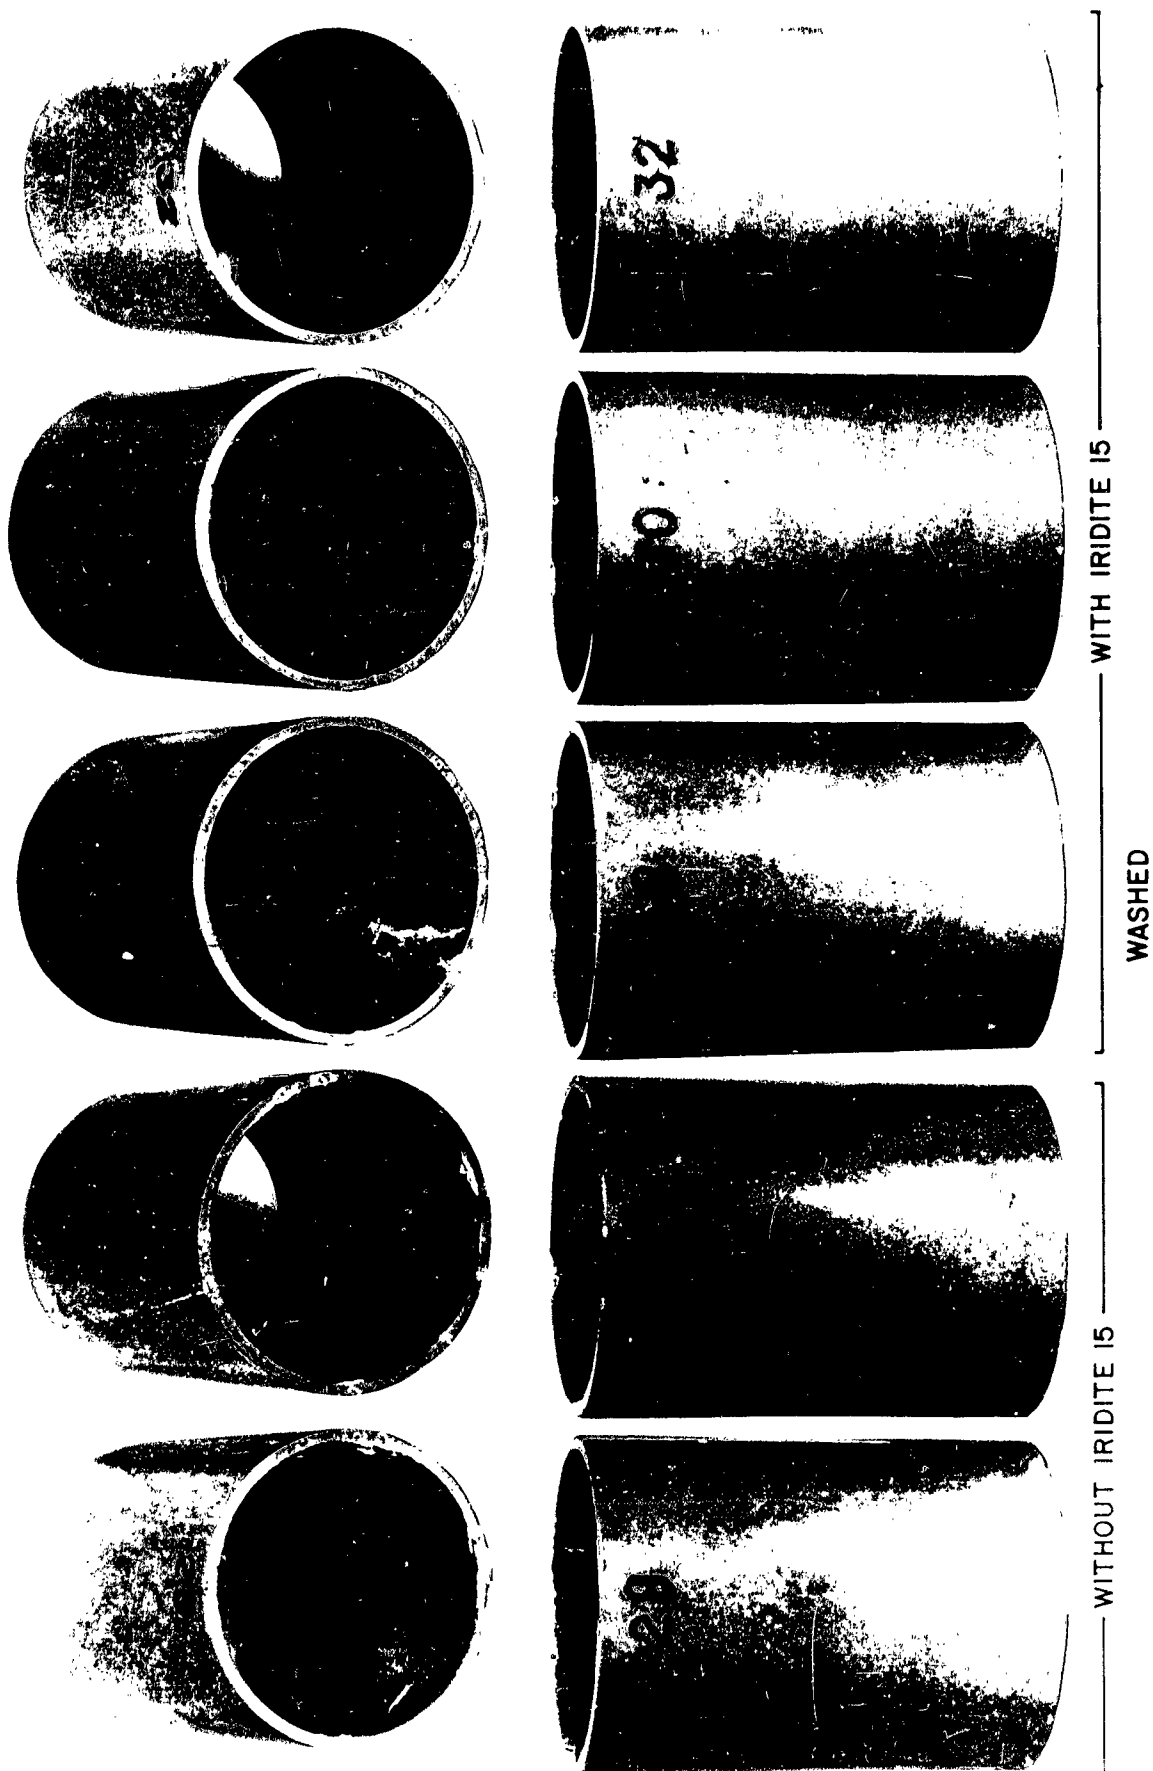
17. Three tubes with Iridite 15 were given a standard Navy paint system and salt spray tested for 240 hours. Tube No. 28 blistered only on the top edge as noted in Figure 9, and tubes No. 30 and 32 did not show any breakdown.

18. A standard Navy paint system was tested on tubes which had not been given the Iridite 15 surface treatment. These tubes, No. 29 and 31, were exposed for 240 hours. As shown by Figure 9, the paint coating blistered on the top edges and lifted from the tubing surface at the edge. Otherwise, the surface of the tubes appeared to be unchanged. Comparison of these results with those of painted tubes with a chemical film surface treatment would suggest no benefit from the surface treatment. However, according to reference (b), paint coatings may be attacked by the basic corrosion products of magnesium, causing underfilm attack which would result in peeling and blistering of the paint coating and loss of paint adhesion over an extended period of time.

FIG. 9 SALT SPRAY (FOG) TEST - 240 HOURS
PAINT COATINGS ON MAGNESIUM TUBES (SEE TABLE I)
